ENGINEERING GEOLOGY REPORT

A.P.N. 155-170-043 and 044
586 Toro Canyon Park Road
Santa Barbara County, California

May 29, 2003

Subject: Engineering Geology Report
Proposed Land Division, A.P.N. 155-170-43, 044
586 Toro Canyon Park Road
Santa Barbara County, California

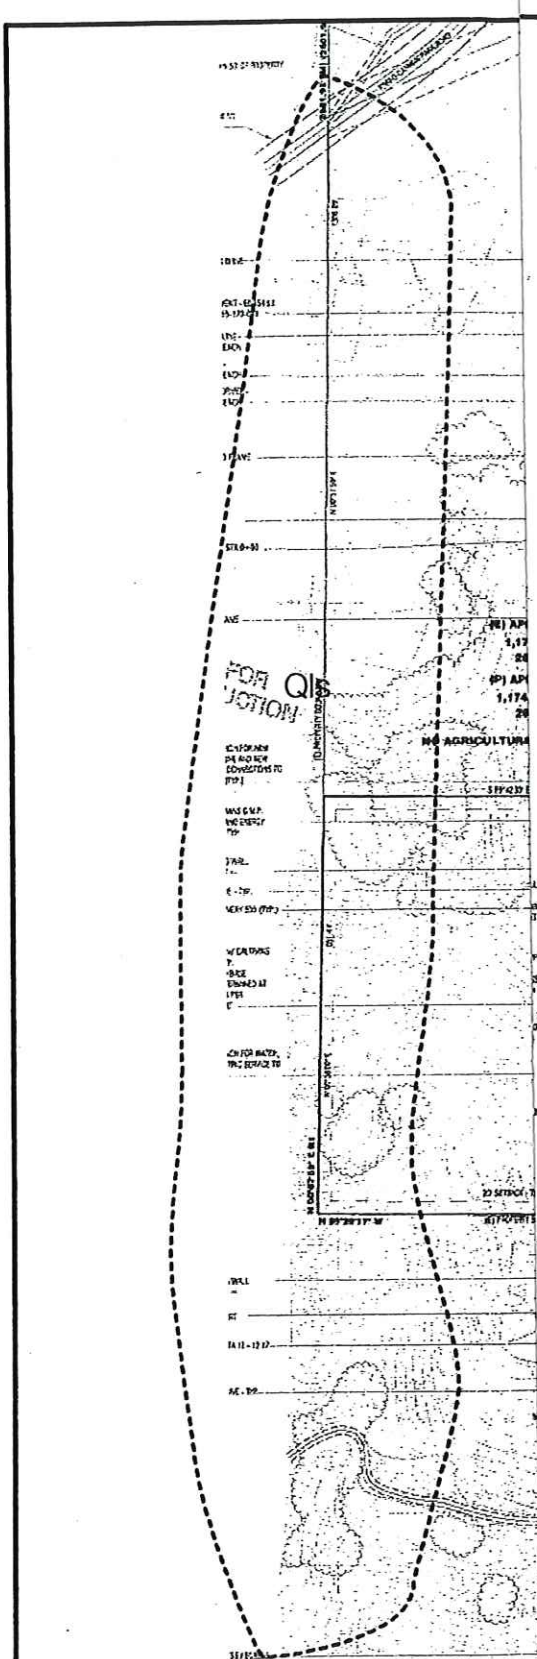
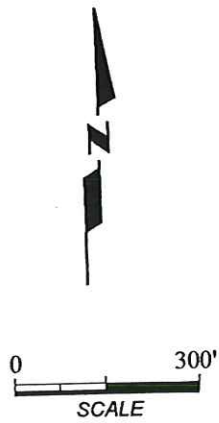
GEOLOGIC MAP

The building areas and adjacent slopes are generally underlain by a shallow thickness of colluvium overlying sandstone, siltstone, and claystone units of the Sespe Formation. A summary of the geologic units encountered in our explorations is provided below. Logs of the explorations are presented in Appendix A. The locations of the explorations are shown on the Geologic Map, Figure 4.

soft to firm, fat (high plasticity) clay. Numerous slickensided surfaces were observed within the clay at a depth of about 12 feet in trench T-2. Sespe Formation was not encountered to the maximum depth explored in Trench T-2, but was encountered at a depth of about 10 feet in Trench T-8. Site observations and aerial photo review (see references for aerial photos reviewed) did not indicate any discernable surface features that would indicate that the landslide has had any recent movement. An alternative interpretation of the deposits could be colluvial and residual soils disturbed from past grading within the building envelope area of Parcel 3. Review of circa 1967 aerial photos and site observations indicate that the slope within the building envelope has had drainage benches graded possibly for agricultural purposes. The approximate limits of the landslides are shown on Figure 3, Landslide Map, and Figure 4, Geologic Map.

With the exception of the older slide mass encountered at the eastern margin of the Parcel 3 building envelope, and the mapped landslide along the west side of Parcel 1, evidence of large-scale or deep-seated landsliding was not observed during our field explorations, or data, aerial photo and literature review. The bedding within the Sespe Formation is inclined to the north at 15 to 35 degrees. A majority of the larger slopes on at the site are east and southeast facing. Surficial erosion and slumping has occurred on the slopes below the access roads. The erosion and slumping has generally occurred because of uncontrolled run-off onto these slopes. Recommendations to reduce the potential for erosion and slumping are provided in the following section.

Although the surface topography is relatively gentle to moderate, and there is no evidence of recent movement, we recommend that a fifty foot structural setback be provided from the landslide mapped on Parcel 3
