FILE:GR06Mar.SimonSlope

RE: *Preliminary Discussion Regarding Slope Instability Issues*  
*Proposed single family residence*  
*15000 Calle Real*  
*Gaviota, California*  
*Assessor's Parcel Number 081-150-28*

**SLOPE STABILITY INVESTIGATION REPORT: Simon Property**  
**March 11, 2006**

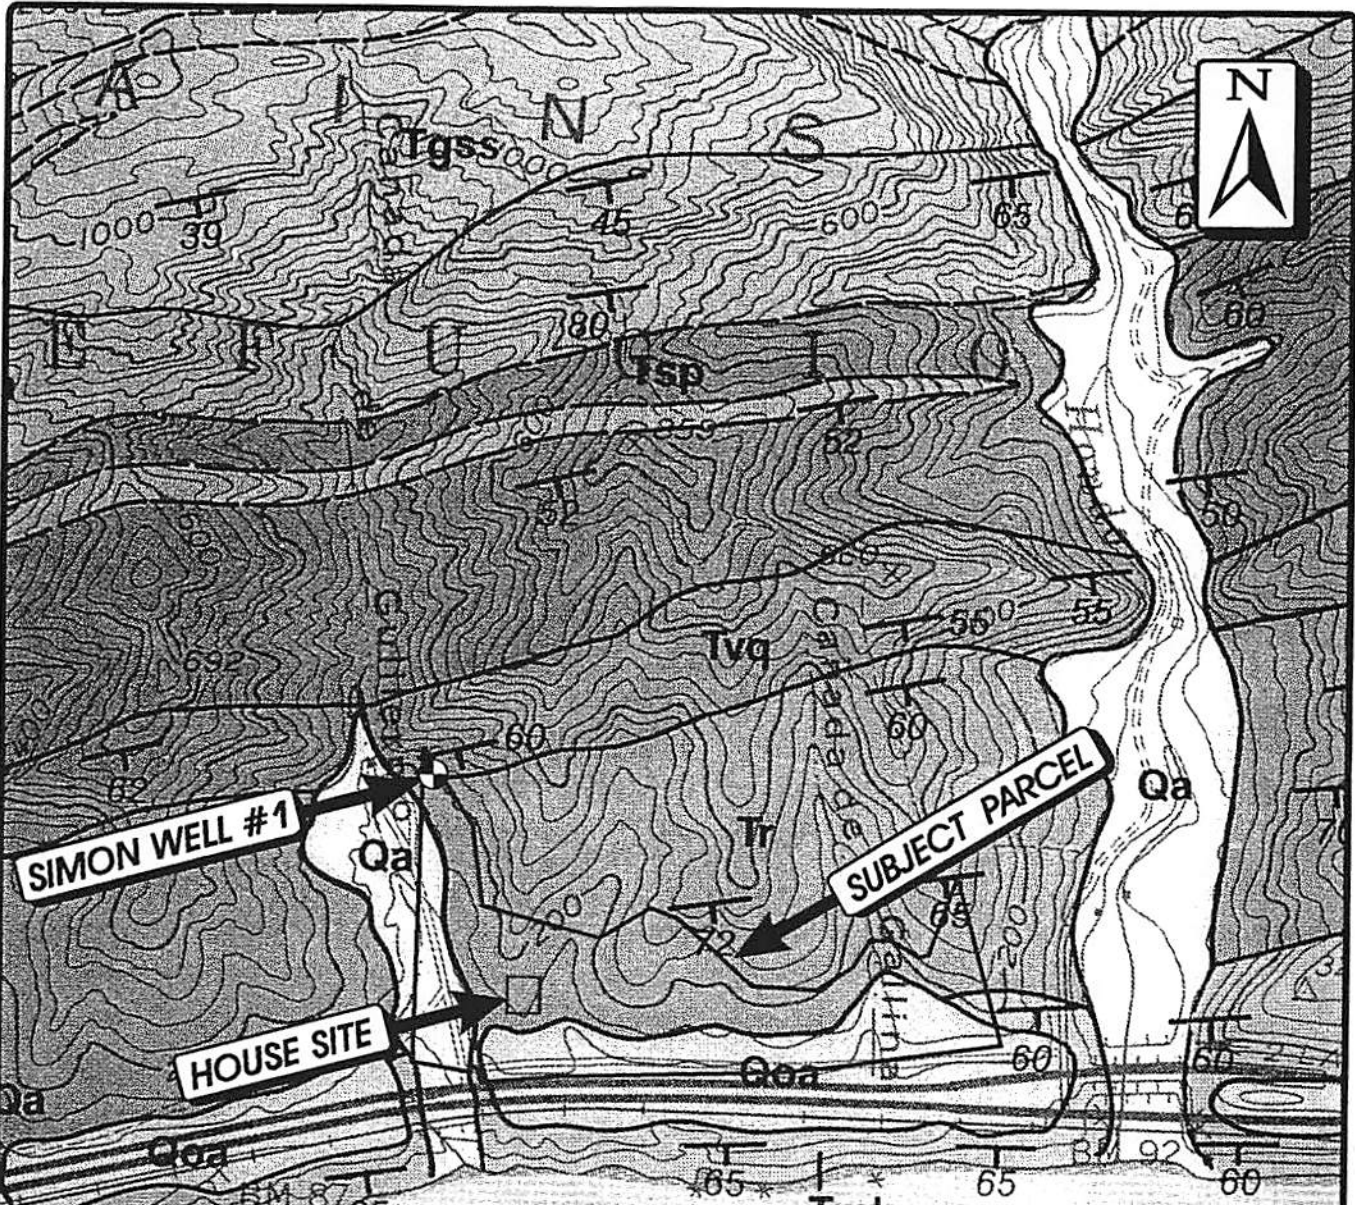
**FIGURE 1**

thirds of the Building Envelope are underlain by Older Alluvium materials. The parent bedrock in the area is composed of shale and mudstone called the *Rincon Formation* (shown as "Tr" on Figure 1). This formation is notorious for forming thick clay rich soils that are prone to deep seated "creep" and landslide deposits on sloping terrain. The focus of this investigation was to identify and map the local landslide deposits in relationship to potential building areas located elsewhere on the property (as opposed to the previously designated and intensively studied Building Envelope).

Based on my 30 plus years of local geologic and slope stability experience in Santa Barbara County, it is my opinion that the existing Building Envelope as shown on Figure 1 and Figure 2 is the only geologically suitable residential site on the subject property. There are no suitable alternative sites located on this parcel that afford a reasonable level of geologic hazard security for residential habitation. Because of the potential for the new residence being viewed by highway traffic along the Highway 101 corridor, you can consider the placement of vegetative screening along the outer (southern) edge of the building pad. As exposed within my Geologic Inspection Trenches excavated along the southern edge of the Building Envelope, there is a moderately thick section of *Older Alluvium* in this area. This material is composed of pebble and sandy conglomerate and gritty sand. I have graphically shown the estimated aerial extent of the Older Alluvium on Figure 2. These earth materials should be permeable enough and contain sufficient sandy material to support the growth of several hard chaparral species such as Oak and Sycamore trees.

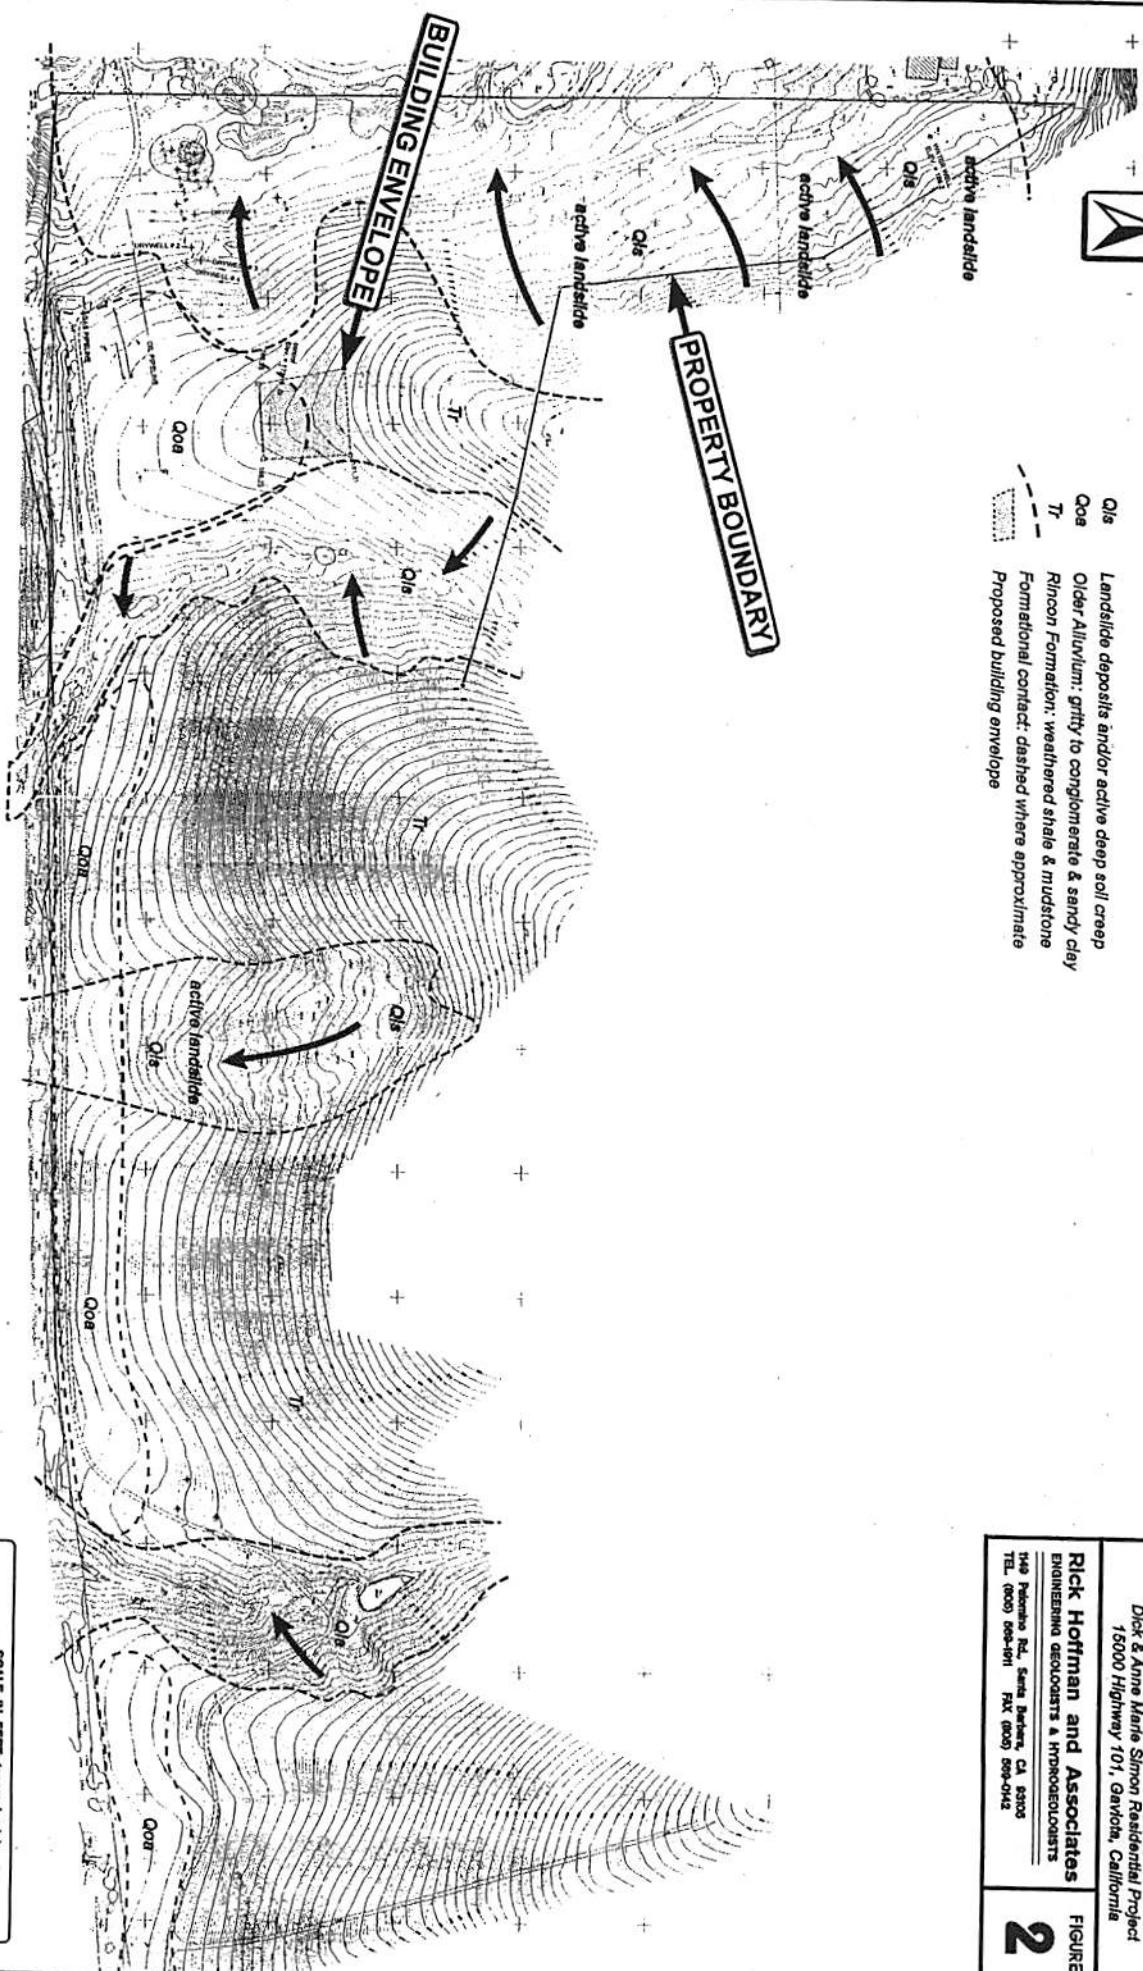
FIGURE  
**2**

My recent detailed geologic mapping and field reconnaissance inspection of the subject property showed the presence of several small to moderate scale landslide deposits on the property. The *Landslide deposits* are composed of highly expansive clay soil and weathered mudstone bedrock that has failed due to oversaturation and structural failure. The landslide deposits have several different forms of failure on this property including shallow and deep seated rotational failure, mudflows, and debris flows. The mudflows can become quite "liquid" in their failure mode, acting like a viscous fluid with a very low angle of repose. Failure can occur on slopes as gentle as 4:1 (horizontal to vertical; approximately 14°). The fluid like mass can "run out" onto essentially flat lying terrain for many tens of feet. Residential construction at the base of these slopes is therefore not recommended.

I have graphically shown the approximate extent of the landslide and deep seated soil creep prone areas on the Figure 2. It is noteworthy that nearly the entire driveway road corridor leading from the Main Gate northward toward Mr. Brown's house (and the alternative residential building area suggested by some members of the public) is underlain by landslide deposits. Residential building along the existing driveway corridor is therefore not recommended.
