**BIOLOGICAL SURVEYS AND
WETLANDS DELINEATION,
SIMON PROPERTY,
GAVIOTA COAST,
SANTA BARBARA COUNTY,
CALIFORNIA**

November 14, 2000

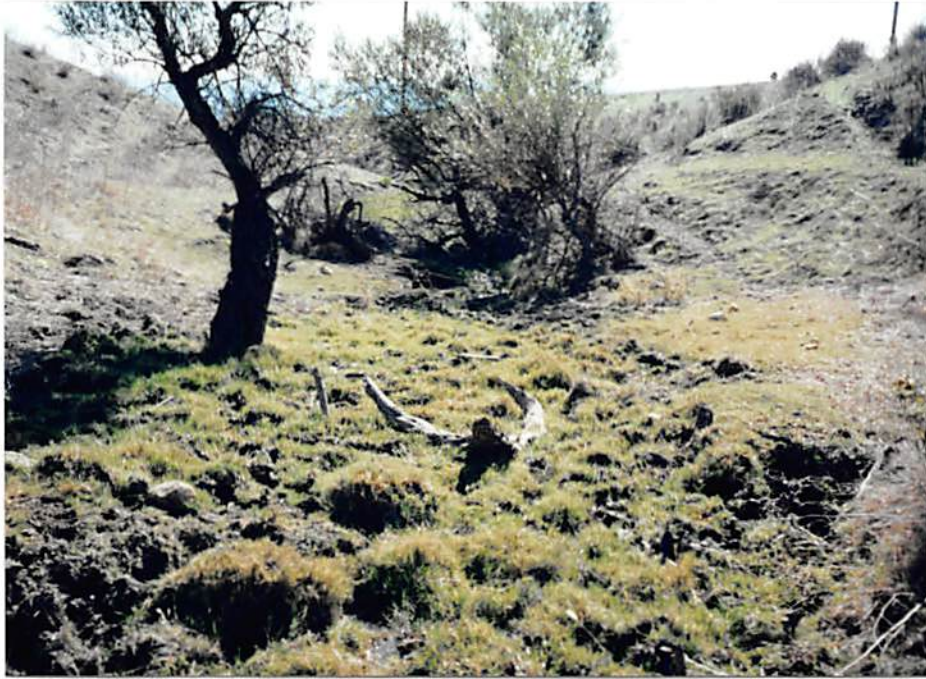
Photo 1: Sampling Station SS-1, northern part of the unnamed drainage

Sampling Station SS-1. This station was located in the northern part of the unnamed drainage in the west-central part of the site. The grassy swale was dominated by rabbitsfoot grass (*Polypogon monspeliensis*) and Bermuda grass (*Cynodon dactylon*); isolated arroyo willow (*Salix lasiolepis*) trees also were present. The hydrophytic vegetation criterion was met. Wetland hydrology was indicated by the presence of ponded water about 1 inch deep. The clay soils had a matrix chroma of 1 and therefore were hydric. Station SS-1 qualifies as ACOE and USFWS wetlands, and as CDFG wetlands and streambeds.

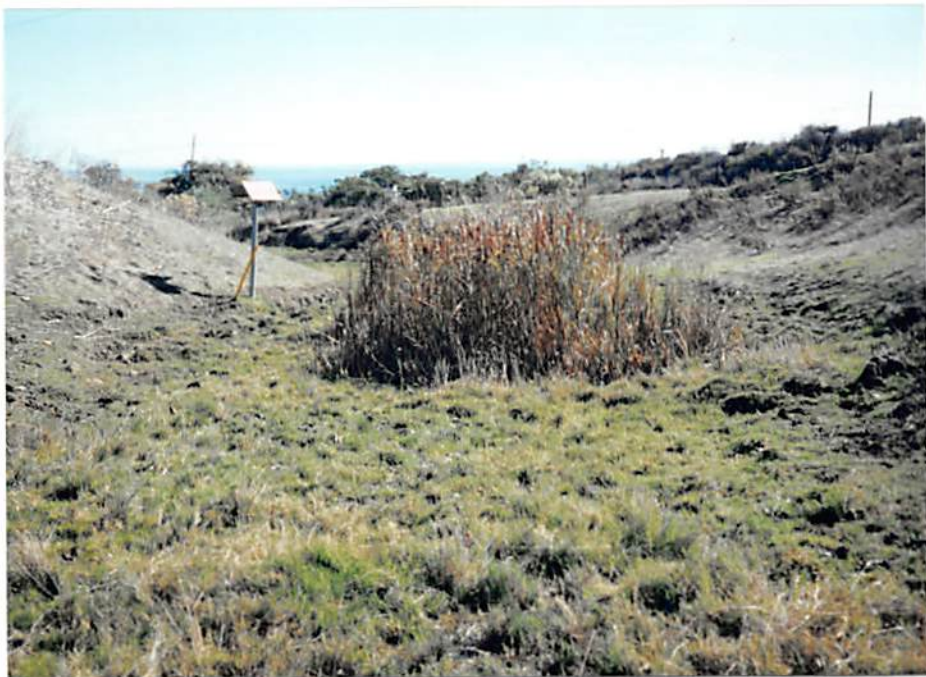
Photo 2: Sampling Station SS-2, southern part of the unnamed drainage

Sampling Station SS-2. This sampling station was established in the southern part of the unnamed drainage in the west-central part of the parcel. Vegetation comprised primarily the marsh species southern cattail (*Typha domingensis*) and prairie bulrush (*Scirpus maritimus*); Bermuda grass (*Cynodon dactylon*) and rabbitsfoot grass (*Polypogon monspeliensis*) also were present. The hydrophytic vegetation criterion was met. Wetland hydrology was indicated by the presence of ponded water about 2 inches deep. The clay soils were hydric, with a matrix chroma of 0. Sampling Station SS-2 qualifies as ACOE and USFWS wetlands, and as CDFG wetlands and streambeds.

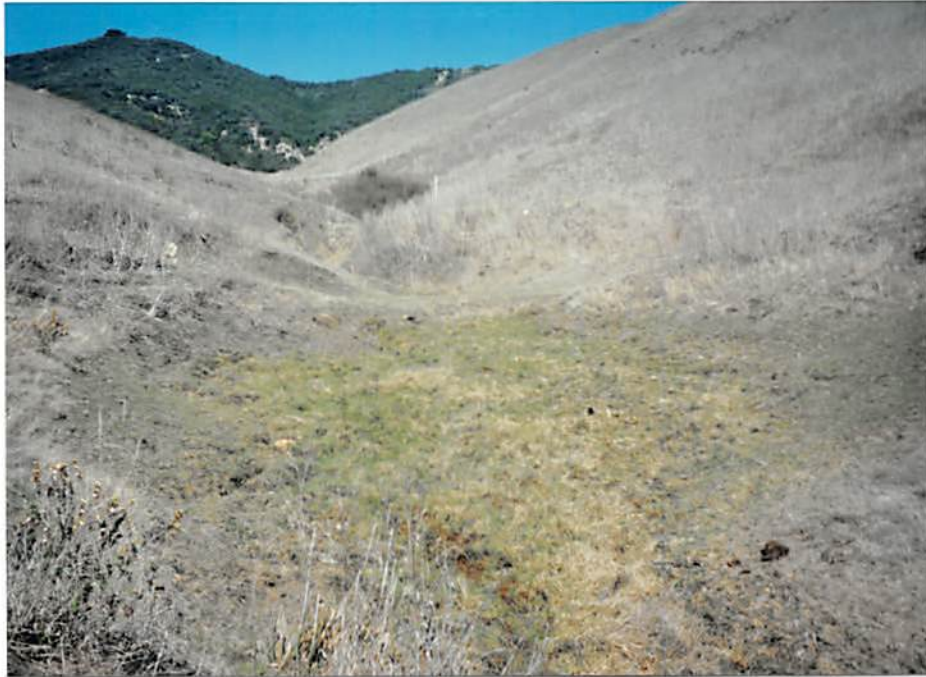
Photo 3: Sampling Station SS-3, northern part of Cañada de la Gallina

Sampling Station SS-3. This station was located in the northern part of Cañada de la Gallina in the eastern part of the site. The grassy swale was dominated by rabbitsfoot grass (*Polypogon monspeliensis*) and Bermuda grass (*Cynodon dactylon*), satisfying the hydrophytic vegetation criterion. Wetland

hydrology also was present, indicated by ponded water about 1 inch deep. The silty clay soils had a matrix chroma of 0 and therefore were hydric; organic matter and roots also were present in the soil. Station SS-3 qualifies as ACOE and USFWS wetlands, and as CDFG wetlands and streambeds.

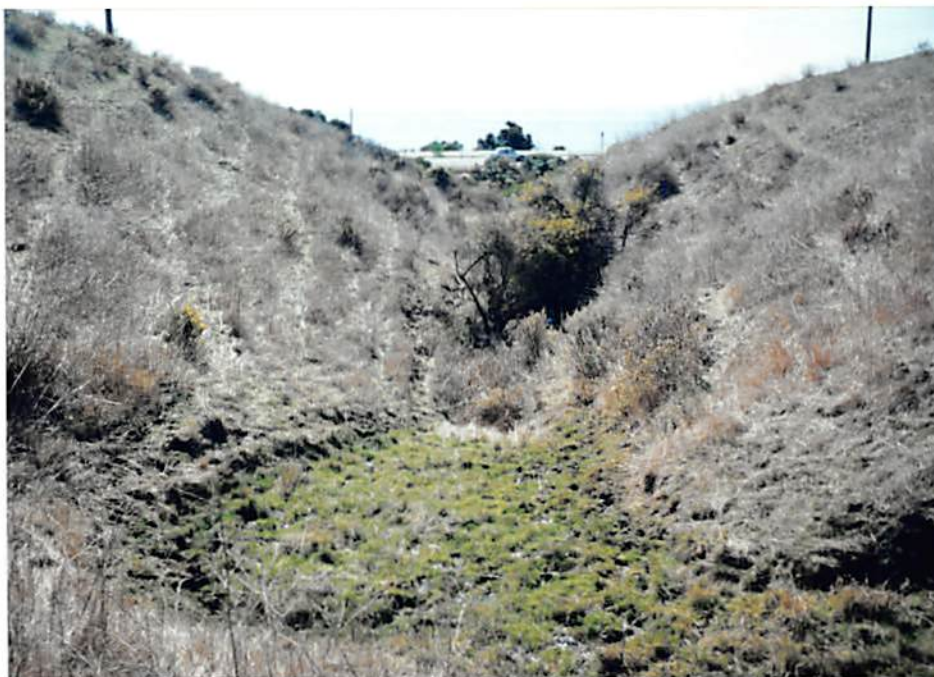
Photo 4: Sampling Station SS-4, southern part of Cañada de la Gallina

Sampling Station SS-4. This station was located in the southern part of Cañada de la Gallina in the eastern part of the site. A small clump of prairie bulrush (*Scirpus maritimus*) occurred at this station; other species were brass buttons (*Cotula coronopifolia*) and Bermuda grass (*Cynodon dactylon*). Isolated trees of elderberry (*Sambucus mexicana*) also were present. The hydrophytic vegetation criterion was met. Wetland hydrology was indicated by the presence of ponded water about 2 inches deep. The clay soils had a matrix chroma of 1 and were mottled, and therefore were hydric. Station SS-4 qualifies as ACOE and USFWS wetlands, and as CDFG wetlands and streambeds.

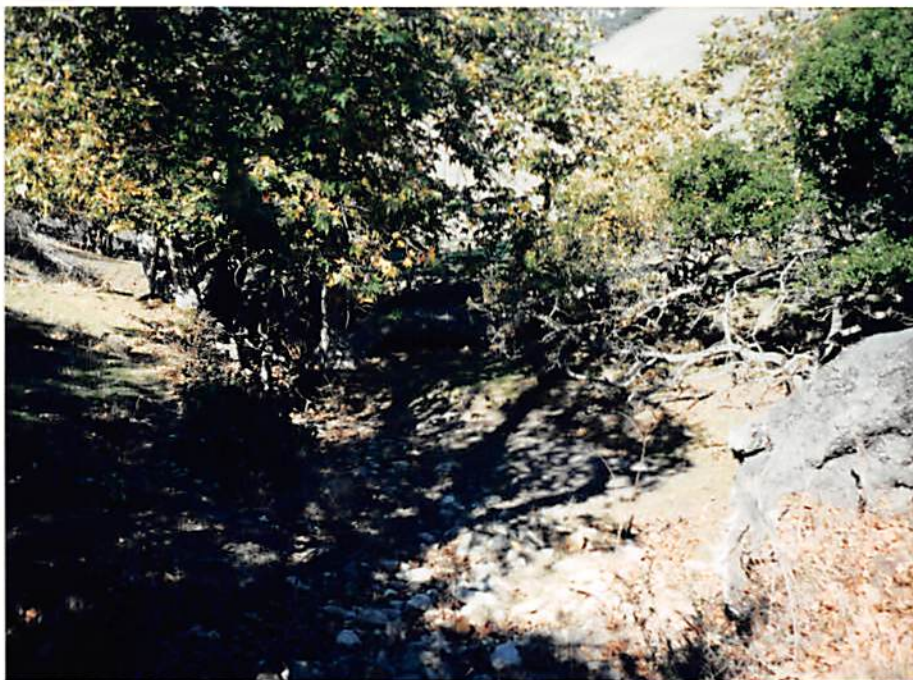
Photo 5: Sampling Station SS-5, Cañada de Guillermo

Sampling Station SS-5. This station was located in the southern part of Cañada de Guillermo near the western boundary of the site. Overstory vegetation consists of western sycamore (*Platanus racemosa*) and coast live oak (*Quercus agrifolia*); the understory contains some rabbitsfoot grass (*Polypogon monspeliensis*). The hydrophytic vegetation criterion was satisfied. Pools of water a few inches deep occur in places in the rocky streambed; wetland hydrology also is indicated by the presence of debris deposits, banks, and shelving. The sandy riverwash soils had cobbles and were too rocky to dig; hydric soils could not be confirmed. Station SS-5 qualifies as ACOE waters of the United States, as USFWS wetlands, and as CDFG wetlands and streambeds.
